Monitoring Pays Off

by Konrad Saal

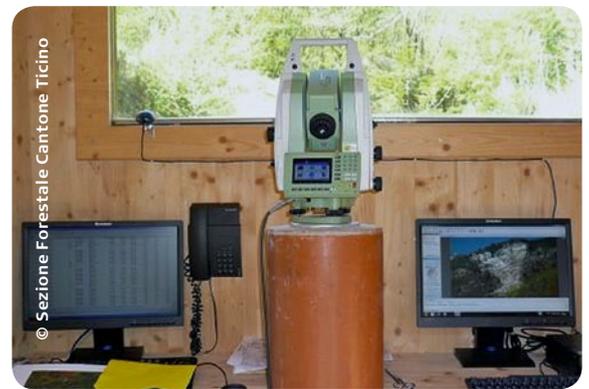
■ Leica TM30 monitoring the area.

The automatic monitoring system has provided continuous information about every movement in the affected zone. Two years ago a Leica TM30 Monitoring Sensor was installed on a stable pillar below the slide area and connected to the Leica GeoMoS moni-

toring system. Since then the sensor has monitored 15 observation points located inside and outside the danger zone every hour, 24/7. The results are automatically forwarded to an FTP server in the Forestry Department and then analyzed by experts.

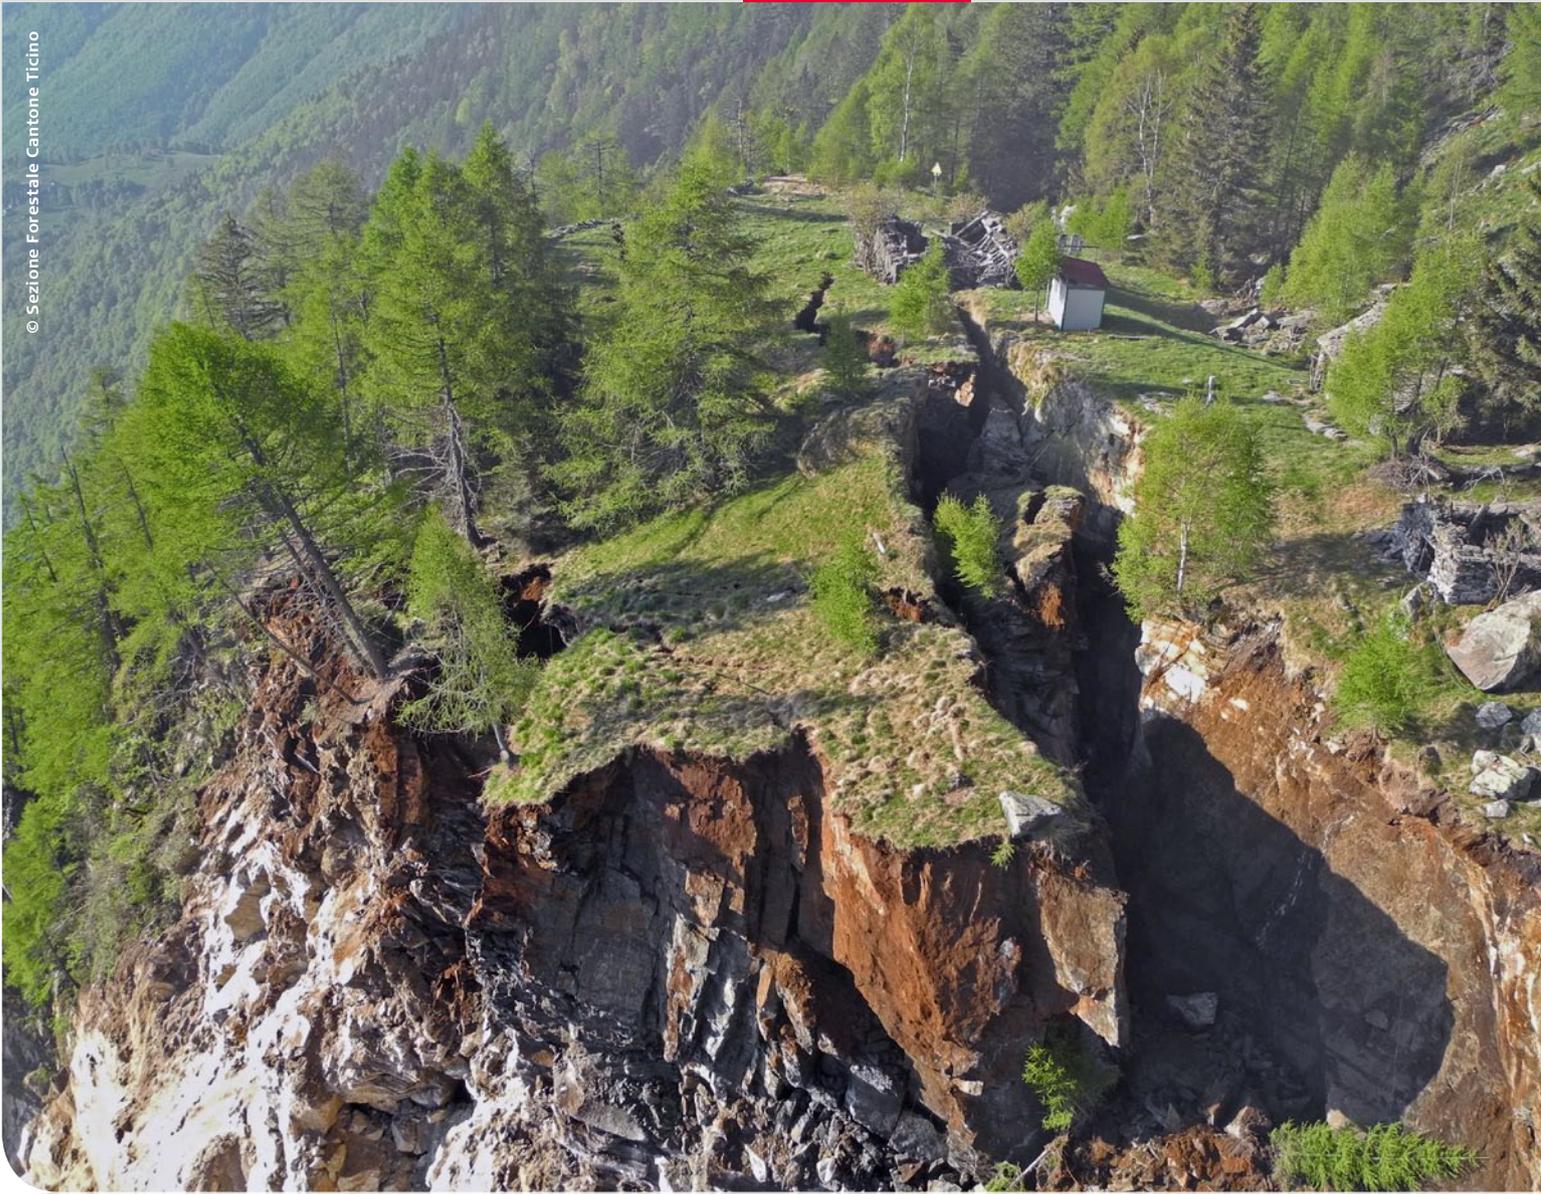
■ This is where 300,000m³ of rock crashed down 1,000m to the valley floor.

During the night of 14 May this year, 300,000m³ (392,000yd³) of rock broke off the Valegion mountain and crashed down 1,000m (3,281ft) to the valley floor in the Swiss canton of Ticino, near the village of Preonzo. Thanks in part to Leica Geosystems' Deformation Monitoring solution GeoMoS local authorities were able to evacuate the valley's industrial zone and to close the A2 highway and several cantonal roads at an early stage.
